THE  
ONTARIO WATER RESOURCES  
COMMISSION  
WATER POLLUTION SURVEY  
of the  
TOWNSHIP OF MARKHAM  
COUNTY OF YORK

February 1966

DIVISION OF SANITARY ENGINEERING

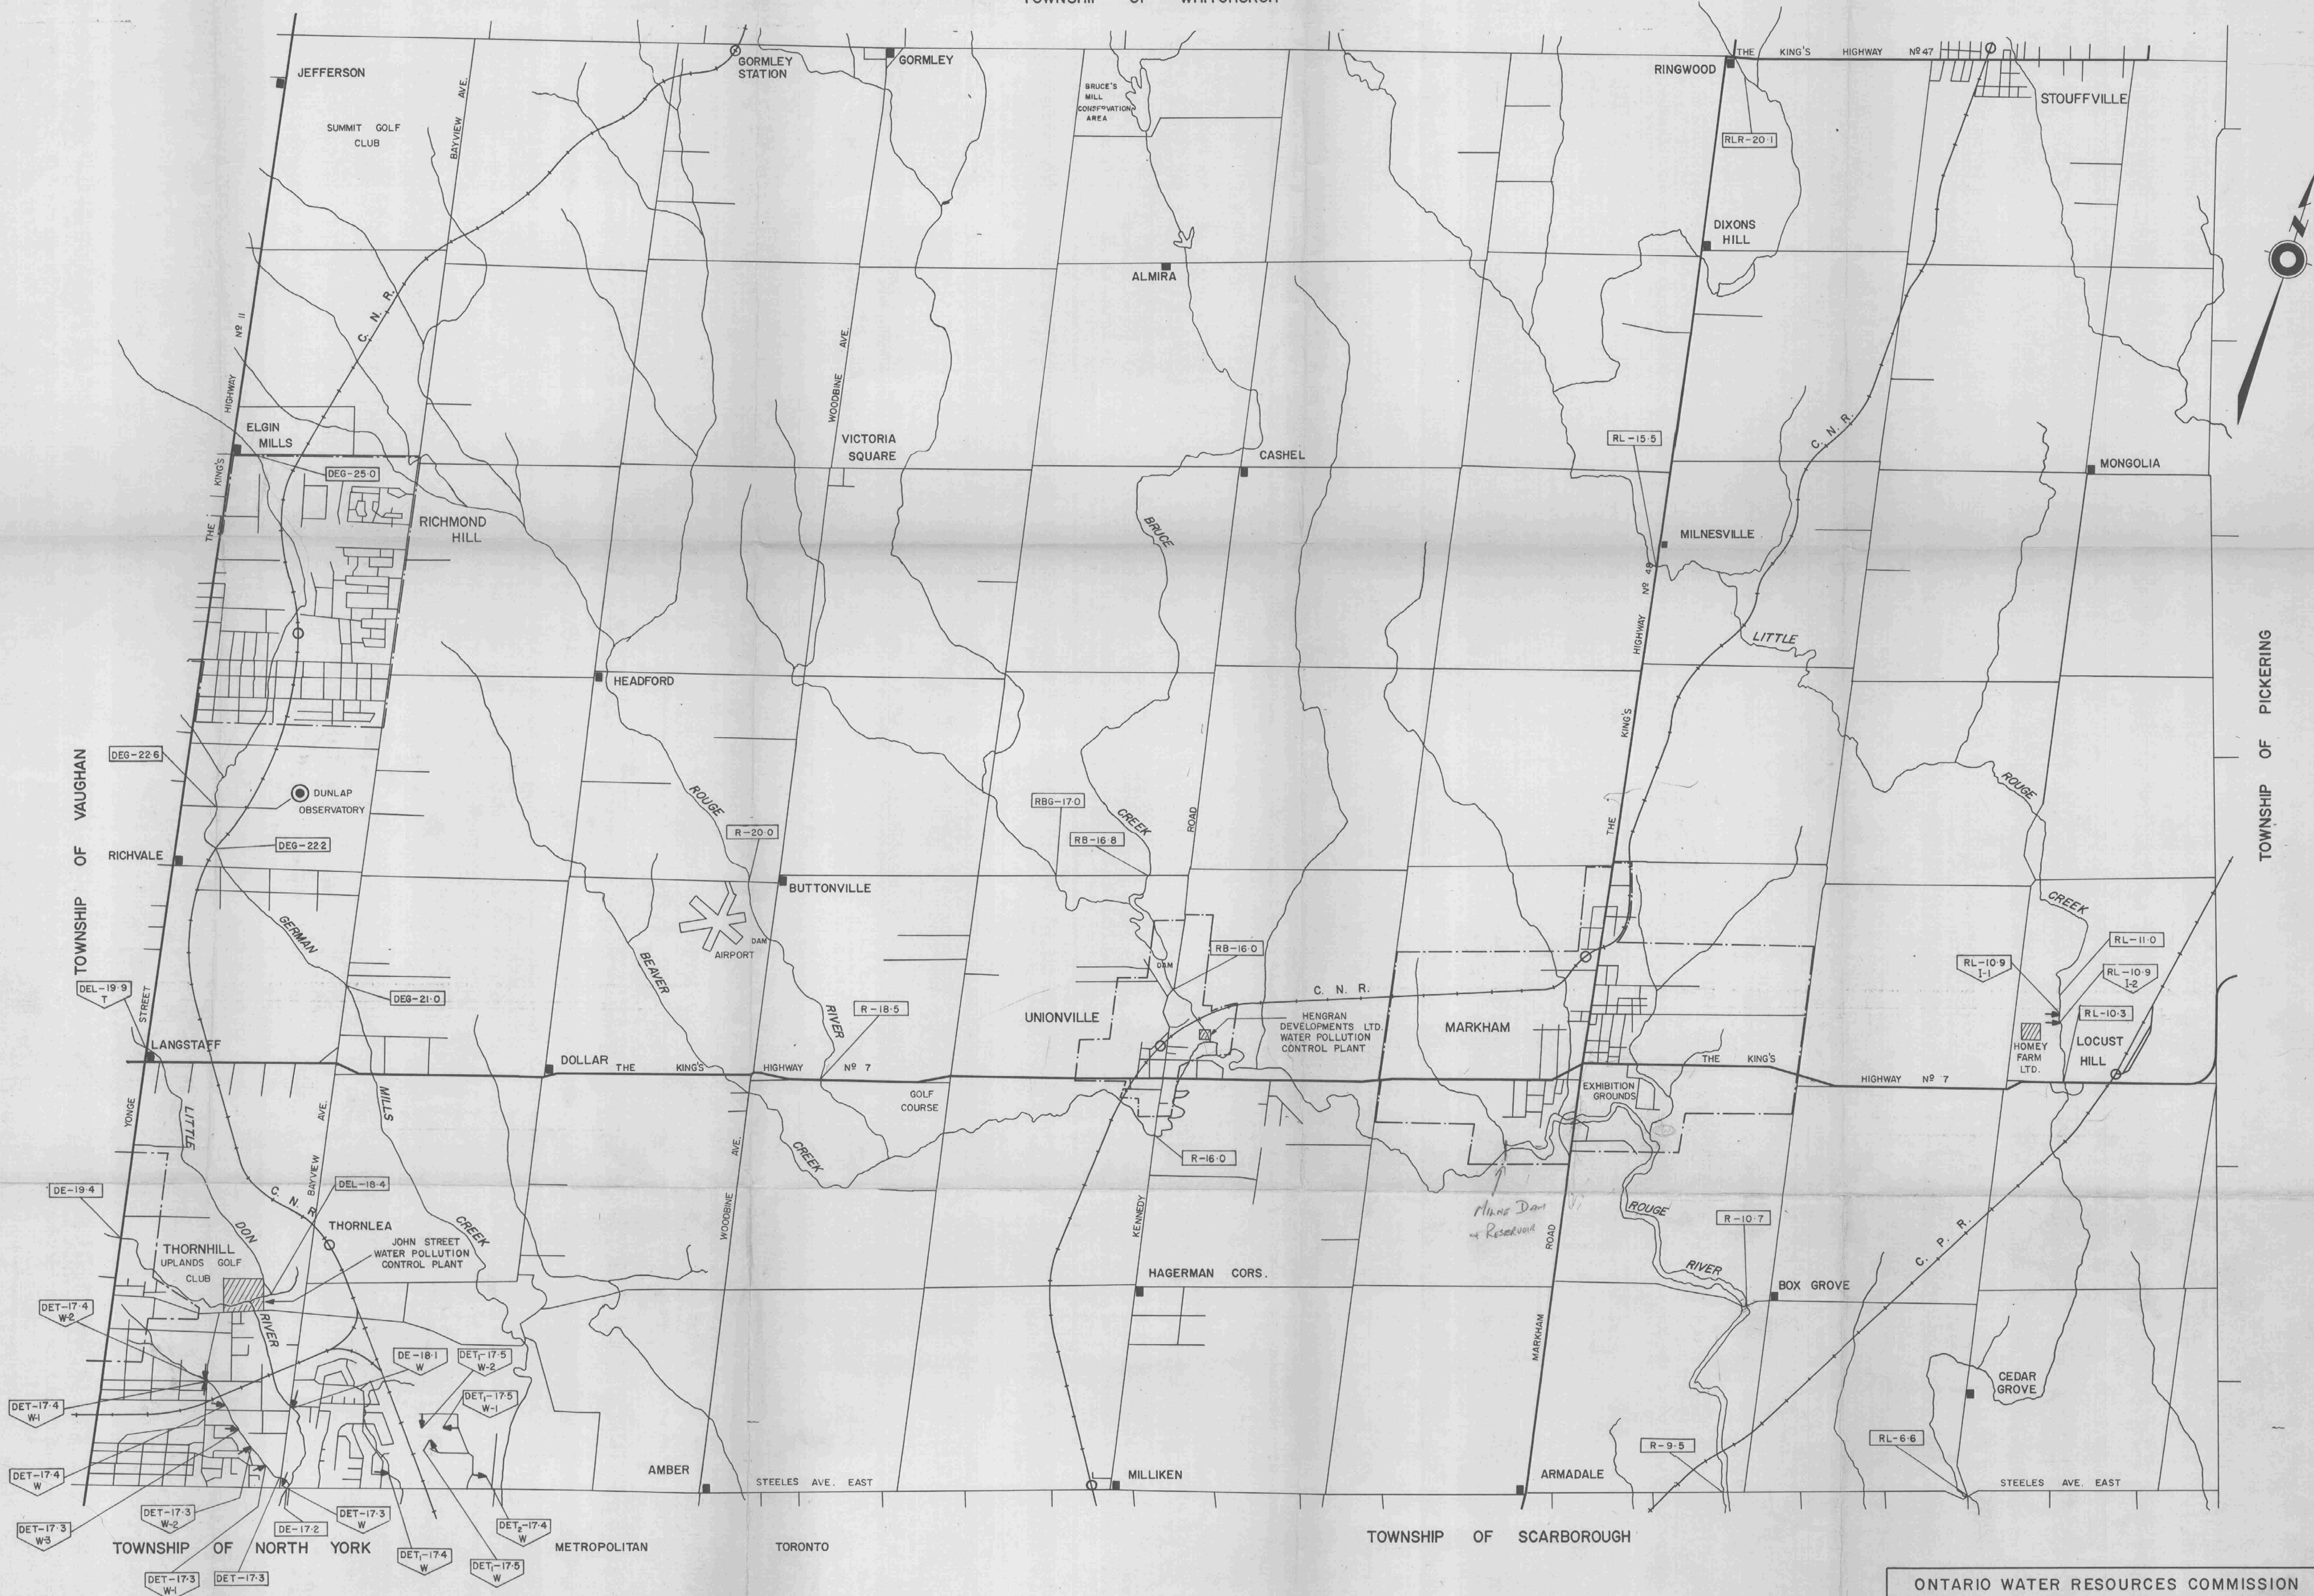
- DE-17-2 — SAMPLING POINT SHOWING STREAM AND MILEAGE
- DE-18-1 — STREAM AND MILEAGE AT OUTFALL
- W — STORM SEWER
- T — SEWAGE TREATMENT PLANT
- I — INDUSTRIAL SEWER
